SESC Plan	Inspection Report	
		Proj	ect Information	
Name			Former Ciba-Geigy	Facility
Location		180 Mill St, Crar	nston, RI (Plat 4, Lof 11	(02)
DEM Perm	nit No.	18-0048 / RI		
Site Owne	r	Name Joseph Guarnaccia	Phone	Email
Site Opera	ntor	Name Juson Oliver	Phone	joseth.guarnaccialbast.
			ction Information	
Inspector	Name	Aaron C. Ting	Phone 978-577-7138	Email Otion Propings It -
Inspection	1	9/18/19	Start/End Time 0 7:00 /07:	ating eaeiconsultants
Inspection		-storm event During st		
		3	orm event	t 🖸 Other
Last Rain I	1.	Duration (hrs):	Approximate Rainfall (in):	
Thend	e Location & S	Source:	tate Ai-port AI	M/A
Weather at	time of this in	spection:	ic might his

APPENDIX C Photographic Documentation

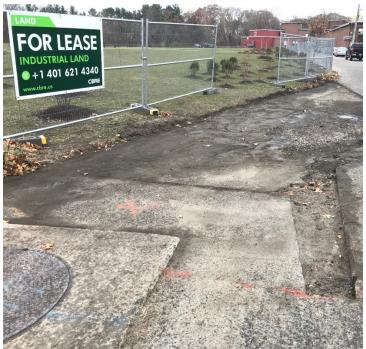
Photo 1: SES/KCI restoring the sub-base prior to emplacing new asphalt in area designated for repair (facing south).

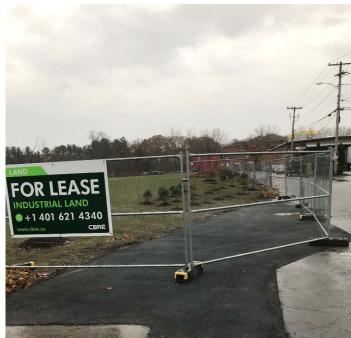
Photo 3: Overview of newly installed asphalt (facing south).

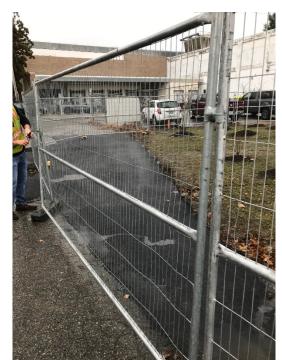
Photo 2: Repaired asphalt pavement. SES/AEI adjusting temporary fence to protect newly installed asphalt (facing north).

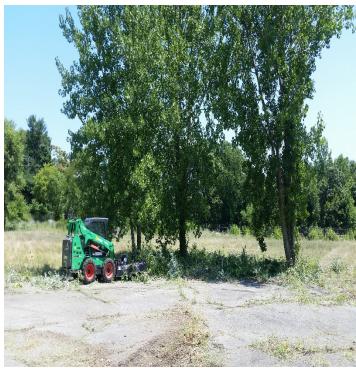
Photo 1: SES clearing site using skid steer with brush hog attachment (facing southeast).

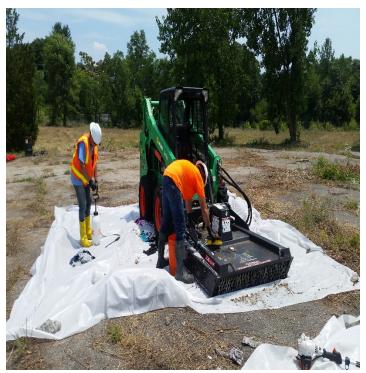
Photo 2: Performing decontamination of brush hog attachment and skid steer tires (facing southeast).

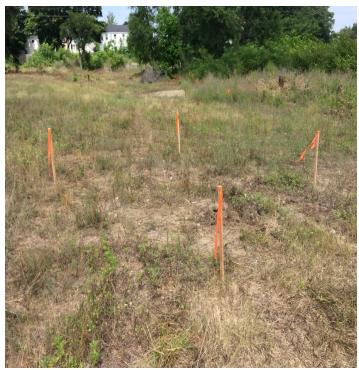
Photo 3: Survey and staking of excavation areas. Flagging color designates soil types (orange = non-TSCA soils) (facing north).

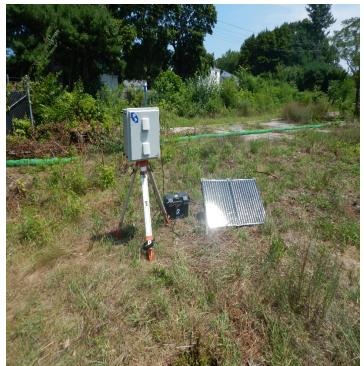
Photo 4: Perimeter air monitoring equipment utilized during entire course of work (facing northeast).

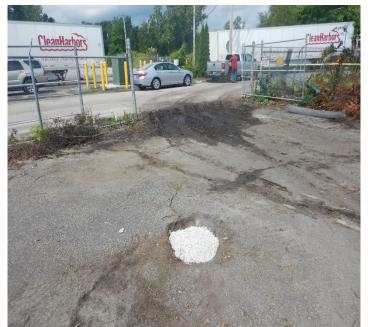
Photo 10: Former monitoring well location filled with bentonite grout to the surface in accordance with RI monitoring well decommissioning standards (facing northwest).

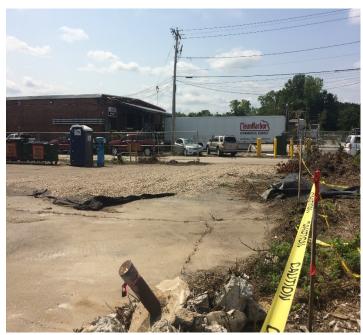
Photo 15: Construction entrance leading to asphalt pavement. Stone underlain with filter fabric (facing west).

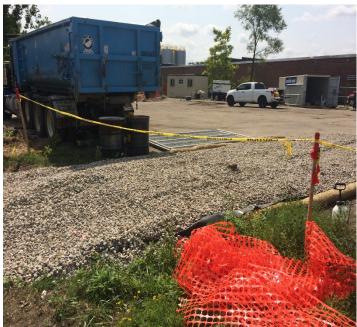
Photo 16: Decontamination pad constructed of stone overlaying impermeable liner and surrounded by straw wattle (facing southwest).

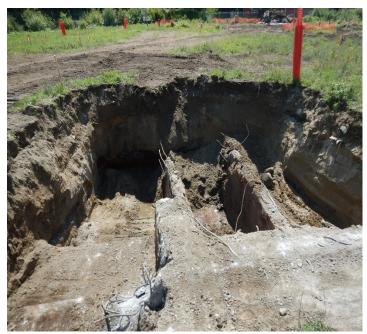
Photo 21: Numerous large concrete structures, foundation walls and slabs encountered (facing southeast).

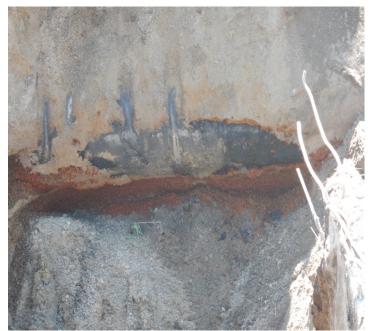
Photo 22: Large, approx. 24-inch diameter pipe, presumed to be part of the former facility stormwater drainage system. Pipe was left in place (facing south).

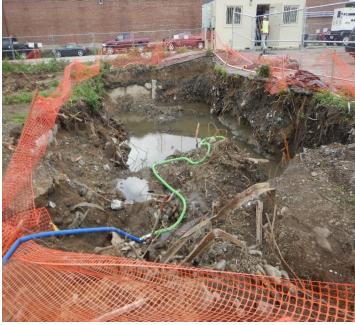
Photo 31: Dewatering deep excavation using trash pumps; water being transferred via hosing to filtration/carbon system and frac tanks (facing west).

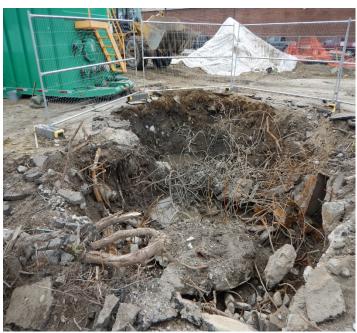
Photo 39: Large quantities of debris, i.e., rebar, concrete, brick and steel in excavations (facing west).

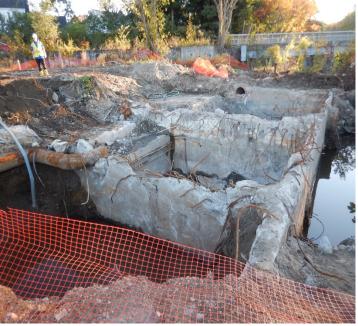
Photo 40: Large concrete structures uncovered while excavating in the FEMA floodway (facing northeast).

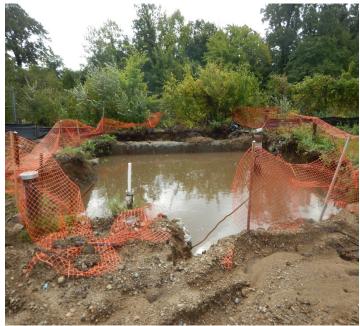
Photo 46: TP-5 excavation after heavy rainfall. Water depth is approximately 6-7 feet bgs (facing east).

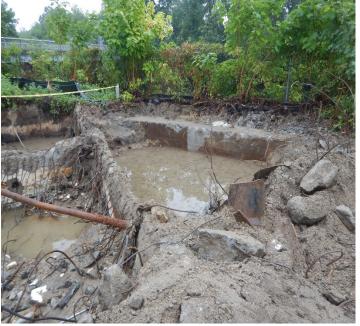
Photo 56: Concrete structures encountered on the northeast side of the property in the Floodway. Water contained inside the structure is rainwater (facing northeast).

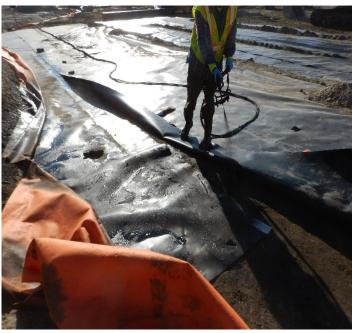
Photo 72: SES adjoining separate impermeable liner panels using an asphaltic spray (facing southwest).

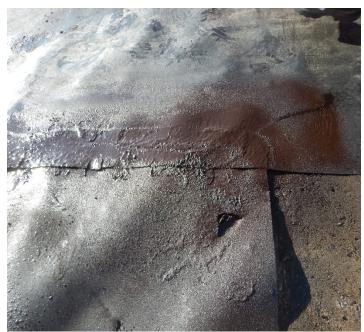
Photo 73: Closeup of sealed impermeable liner panels (facing west).
